Manhole Inspection Summary

Manhole # S43I2_016MH

Location Address: **1233 Church St** Cross Street: **Montehill Ave**

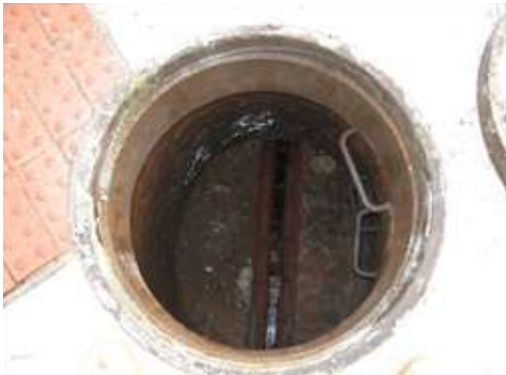
Top View

steps

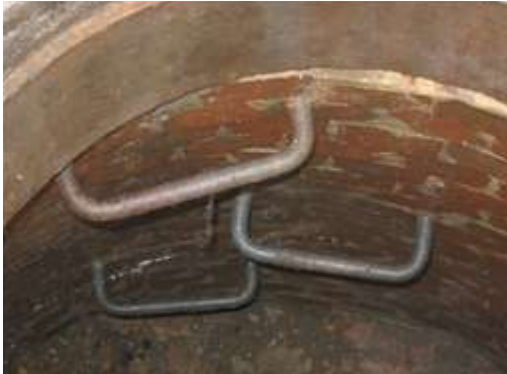
Defect 1

debris

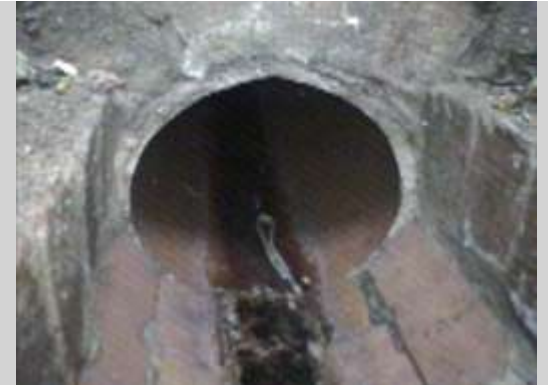
12 O'Clock Outflow

8 in. Circular Gravity Sewer
Pipe Out @ 12 O'Clock

Pipe Height: **10.8** (in.) Rod and Bar (Angled)
Pipe Material: **Clay** ☐ Pipe Lined
Invert Depth: **6.58** (ft.) Flow Characteristics: **Fast**
Deposits: ☒ None ☐ Mud ☐ Sludge ☐ Debris ☐ Grease
Silt Depth: (in.) Deposits Extent:
Infiltration: **None** Pipe Seal Cond: **Sound**

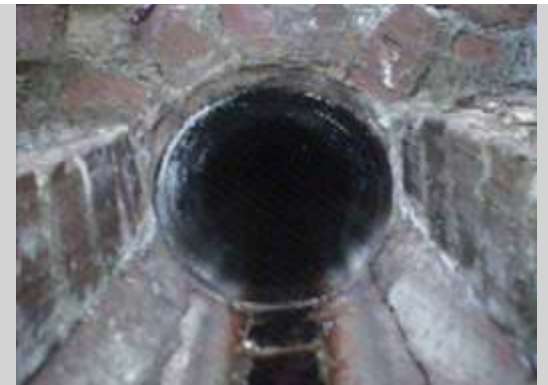
6 O'Clock Inflow

8 in. Circular Gravity Sewer
Pipe In @ 6 O'Clock

Pipe Height: **10.8** (in.) Rod and Bar (Angled)
Pipe Material: **Clay** ☐ Pipe Lined
Invert Depth: **6.16** (ft.) Flow Characteristics: **Fast**
Deposits: ☒ None ☐ Mud ☐ Sludge ☐ Debris ☐ Grease
Silt Depth: (in.) Deposits Extent:
Infiltration: **None** Pipe Seal Cond: **Sound**
